Advanced Stirling Radioisotope Generator EU2 Anomaly Investigation

The Advanced Stirling Radioisotope Generator (ASRG) Engineering Unit 2 (EU2) is the highest fidelity electrically-heated Stirling radioisotope generator built to date. NASA Glenn Research Center (GRC) completed the assembly of the ASRG EU2 in September, 2014 using hardware from the now cancelled ASRG flight development project. The ASRG EU2 integrated the first pair of Sunpower's ASC-E3 Stirling convertors (ASC-E3 #1 and #2) in an aluminum generator housing with Lockheed Martin's Engineering Development Unit (EDU) 4 controller. After just 179 hours of EU2 generator operation, the first power fluctuation occurred on ASC-E3 #1. The first power fluctuation occurred 175 hours later on ASC-E3 #2. Over time, the power fluctuations became more frequent on both convertors and larger in magnitude. Eventually the EU2 was shut down in January, 2015. An anomaly investigation was chartered to determine root cause of the power fluctuations and other anomalous observations. A team with members from GRC, Sunpower, and Lockheed Martin conducted a thorough investigation of the EU2 anomalies. Findings from the EU2 disassembly identif

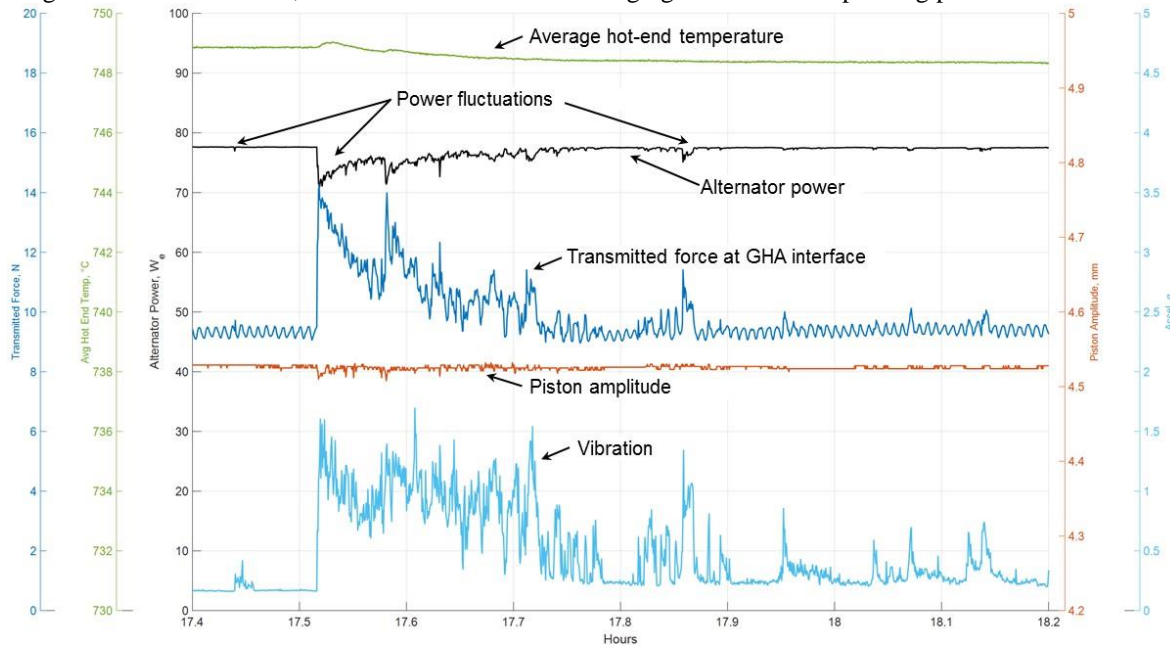
Figure 5. Example of power fluctuations that occurred on ASC-E3 #1 on 14 December 2014.

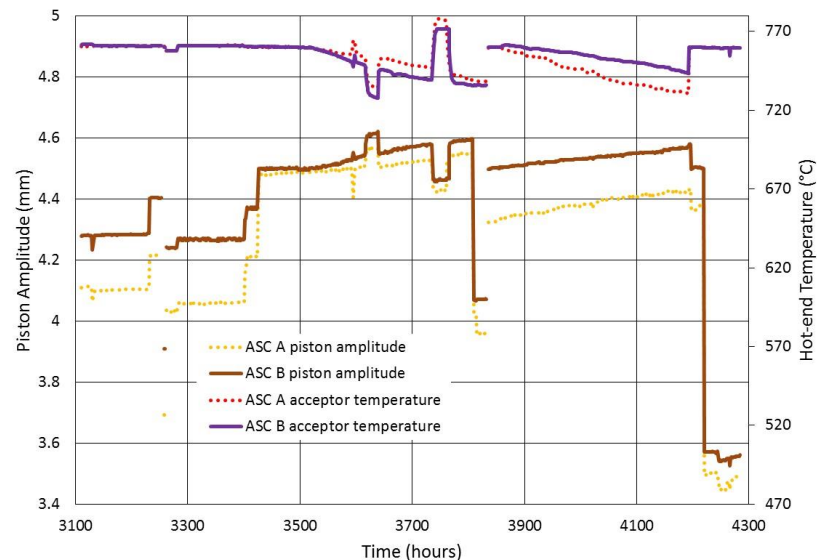
Figure 6. Slow drift in hot-end temperature and piston amplitude during EU2 operation.

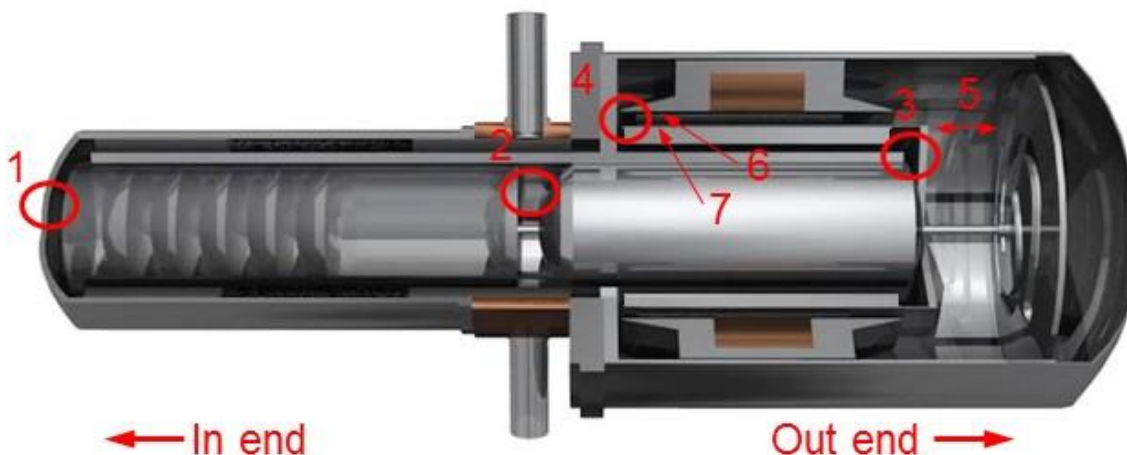
1. Between the displacer dome and the heater head dome.
2. Between the displacer body and the piston nose.
3. Between the magnet can beams and the out end of the cylinder
4. Between the in end of the magnet can and the fasteners on the cylinder clamp ring.
5. Between the ASC Position Sensor (APS) sensor core and the spring stand-off. (The APS sensor core and spring stand-off are not shown in Fig. 8, but their location is indicated by arrows.)

The geometry of ASC-E3 #1 and #2 indicated that collision scenario #3 would occur before collision scenario #4, and no evidence of contact at location #4 was found, so that collision scenario was not considered a possible initiating event.

Figure 8. Cross-section of the ASC convertor with possible internal collision locations identified. Numbers described in Sec. V.A.

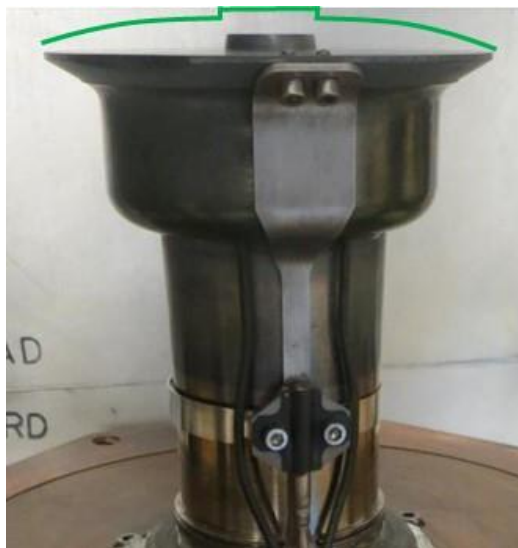
Heat collector crowning did not appear to play a role in the EU2 anomalous observations. Thermal simulations showed that when operating in an argon atmosphere, as was the case with EU2, the gap created by the crowning would not have significantly affected the heat transfer due to the presence of argon in the gap. Further, the change in heat transfer would not have caused the anomalous observations seen in the EU2. However, because 0.06 mm crowning could adversely affect heat transfer between the heat source and the heat collector in vacuum, the team did investigate further to better understand the cause of the crowning.

Figure 10. Exaggerated illustration of crowning of ASC-E3 #1 and #2 across the heat collector

One plausible explanation for heat collector crowning is that it may be caused by creep due to thermal stresses from thermal gradients within the heat collector. Creep occurs at stresses which are less than the high-temperature yield strength of the material. An FEA creep analysis of the ASC-E3 heater head at temperature and pressure did suggest that crowning could occur due to creep.

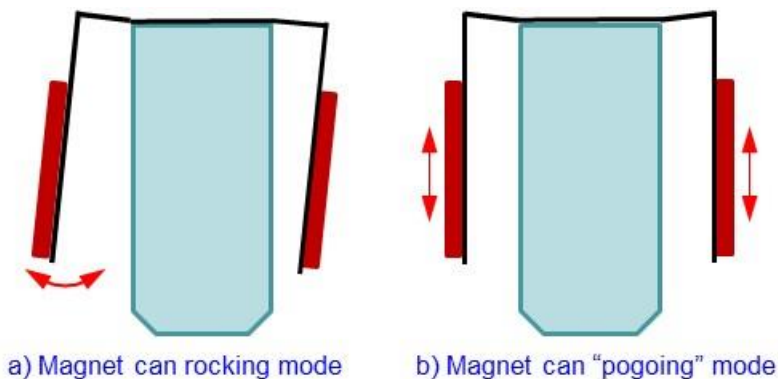
The second aspect is associated with the relatively tight alternator air gaps in the ASC alternator. The ASC alternator air gap in combination with the magnet can’s high L/D ratio (see Fig. 9) is challenging to manufacture, and creates potential failure modes that reduce robustness to unacceptable levels for a critical component in a nuclear power system.

Figure 11. Illustration of two magnet can modes of oscillation.

Further redesign of the ASC alternator tooling and manufacturing processes, to address this aspect is recommended.
